North Las Vegas - VGT

Runway 12 and Taxiway A1

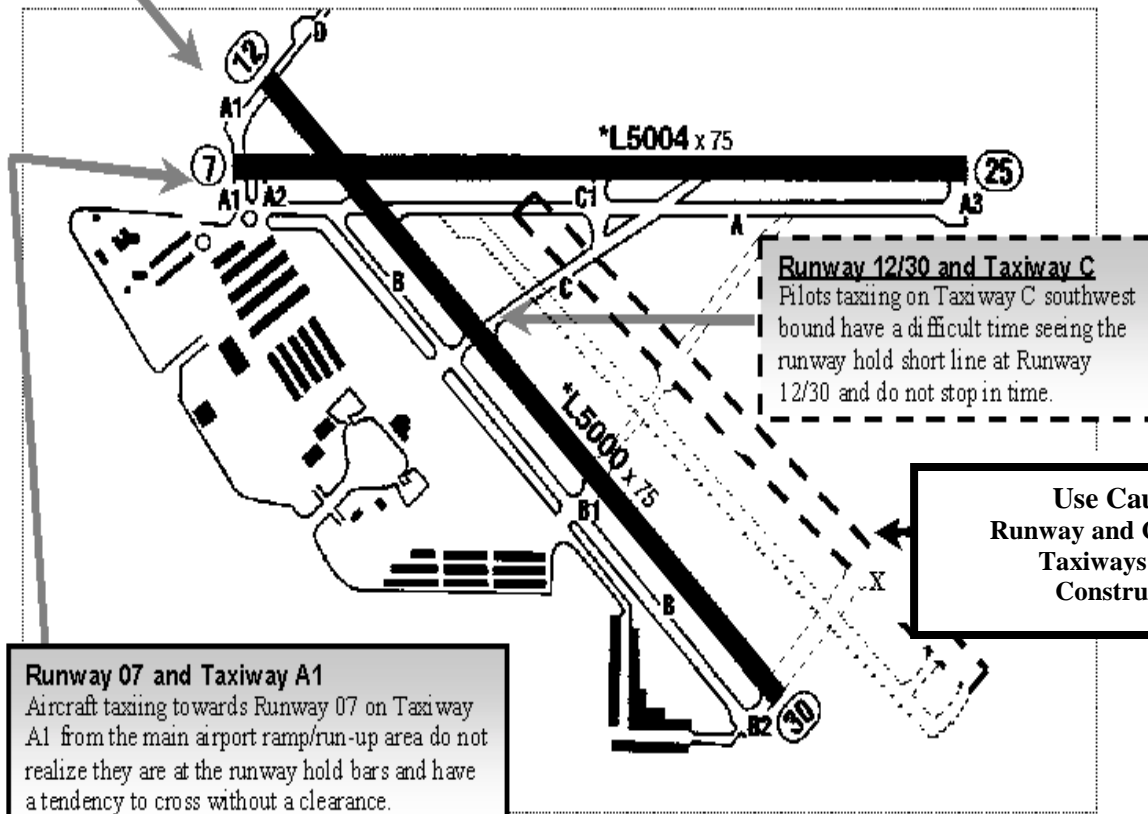
Aircraft taxiing northeast bound on Taxiway A1 fail to hold short of runway 12. This may be due to the curve in this taxiway. Pilots must be very alert to avoid crossing the runway hold bars.

The airport operator has recently repainted the ramp area in the area of runway 07 and taxiway A1 and A2. This effort is very apparent to pilots and should assist pilots in remaining short of runway hold short lines.
